## **Appendix B. Escape report**

**Place:** San Juan de la Costa – off shore site

**Date:** May 02, 2019

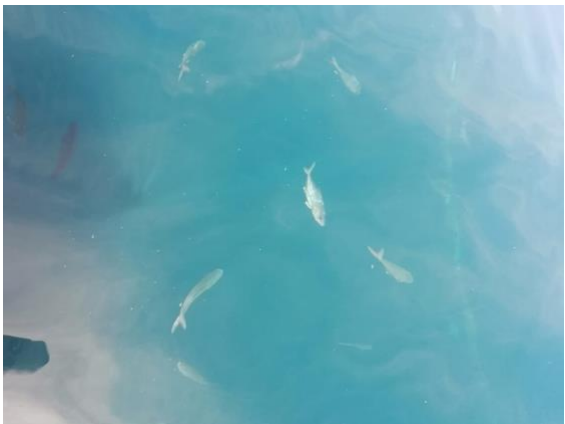
Deformed net openings, damaged originated during the installation of cage 3. These defective net openings allowed fish to push through in a way that would not happen using the standard design.

<p><i>S. rivoliana</i> swimming around the cage.</p>	<p>Fish being recovered.</p>
<p><u>Image</u></p>	<p><u>Image</u></p>
<p><u>Description</u></p>	<p><u>Description</u></p>

1. Daily diving to review the complete net.
2. Identify and correct possible openings in the net that result in larger than standard size.

1. Long term repair by replacing copper alloy wire strands so that areas affected have normal size net opening (40 mm).

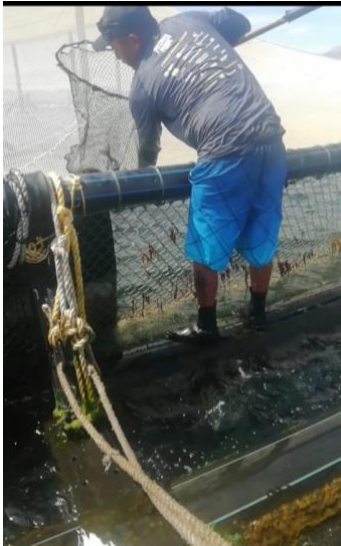
1. On Thursday, April 25th the juveniles of Cohort 3 were released from the nursery net in to the copper net of cage 3.
2. A small group of fish (approximately 60) swam through the copper net.
3. The recovery of the fish was carried out according to protocol and they were returned to the cage.
4. During the following days, similar escapes were observed (approximately five hundred fish). Recovery protocol was activated.
