Appendix B. Escape report

Place: San Juan de la Costa – off shore site

Date: 14 May 2021

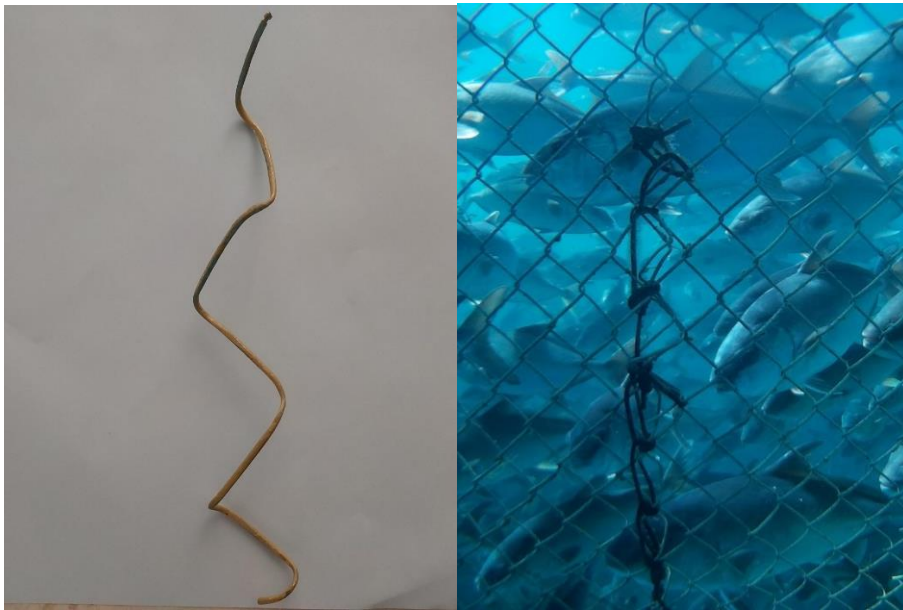
During the inspection of the net, an opening with a length of 1.5m was found. The opening was a vertical slit that opened and closed with the wave action, but its resting state was closed.

The cause was due to a break in one of the vertical copper strands in the net. This allows the strand to work its way down and creates a slit opening.

Description: This is a sample of wire that represents the weak points in the bends and the repair in the offshore pen.

Identify fragile areas and reinforce.

Change net.

Change net material to more resistant and durable according to our local conditions.
